4.2.6.11 2012 Annulus Visual Inspection Results Summary

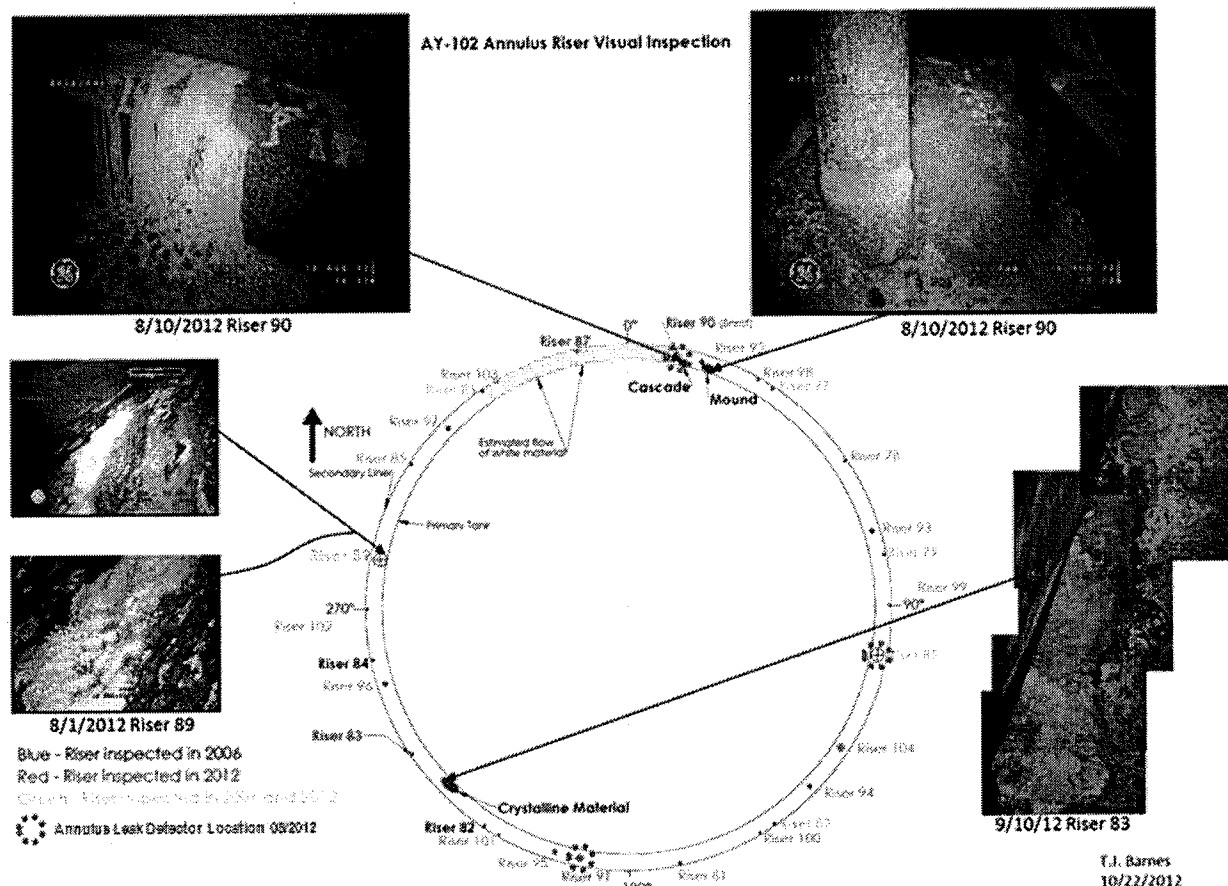
Figure 4-71. Tank AY-102 Visual Inspection Results

The results of the comprehensive annulus inspections identified unexpected changes near in Risers 77, 83, 87, 89, and 90. All of the areas are located on the annulus floor or on the refractory except for Riser 89 where crystal-like growth was found on the primary top knuckle where the primary tank and the secondary liner converge. Figure 4-71 provides a visual summary of the inspections.

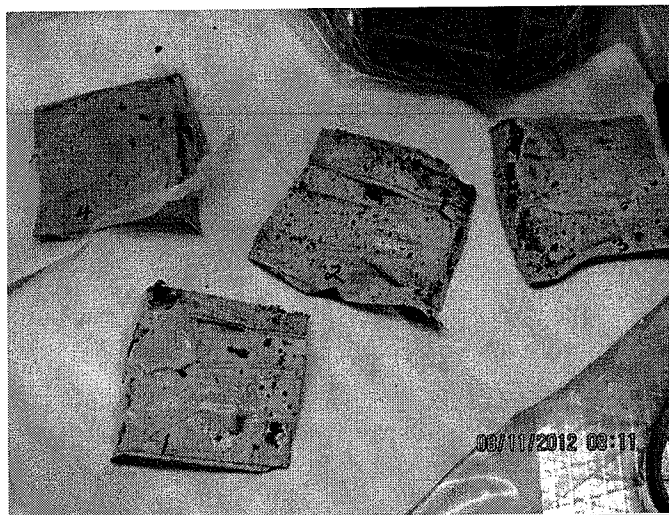
Figure 4-72. Tank AY-102 Riser 90 Duct Tape Survey of Residual Sample Material

Based on the appearance of the duct tape when received at the laboratory, it was decided to remove the double-sided tape, along with the sample, instead of attempting to scrape the sample off of the tape. The tape and sample were removed from the weight and then divided into four sections (see Figure 4-72). Each of the four sections appeared fairly homogenous due to appearance and dose rate. Most of the particulates observed on the tape appeared to be rust, with a few blue-colored flecks.

Results of the SEM analysis concluded that the particulate appeared to be dominated by rust, composed primarily of iron and oxygen, as expected.

The scattered blue particulate appeared to be a type of paint. Analysis by energy-dispersive X-ray spectroscopy (EDS) indicated a kaolinite mineral is the filler in the paint. Cellulose fibers were also present.
